WAR DEPARTMENT
U. S. ARMY AIR FORCES
REPORT OF AIRCRAFT ACCIDENT

Accident No. 4808-27.501

(1) Place Prestwick, Scotland. (2) Date 28/8/44 (3) Time 0055 GMT
AIRCRAFT: (4) Type and model C-54A (5) S. No. 92-7217 (6) Station La Guardia, New York
Organization: (7) ATC (8) Am. Airlines (9) (Squadron)

SUBJECT : Report of Crash of C-54, Number 171.

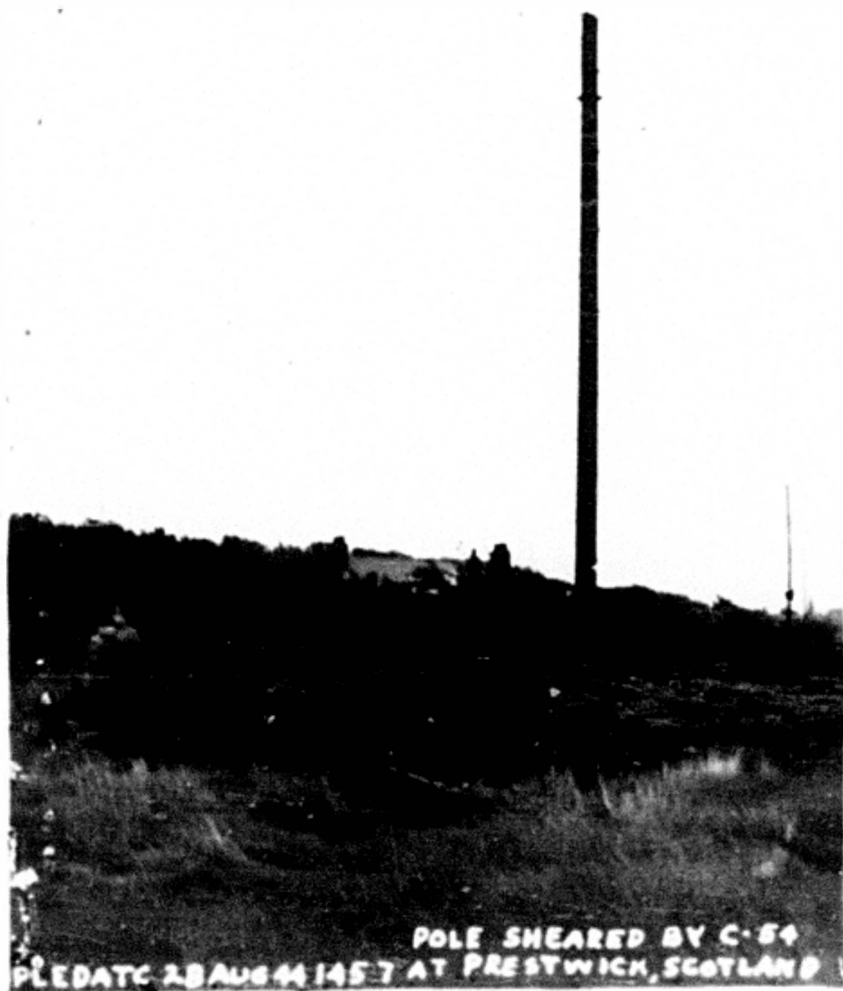
POLE SHEARED BY C-54
PLEDATC 28 AUG 44 1457 AT PRESTWICH, SCOTLAND

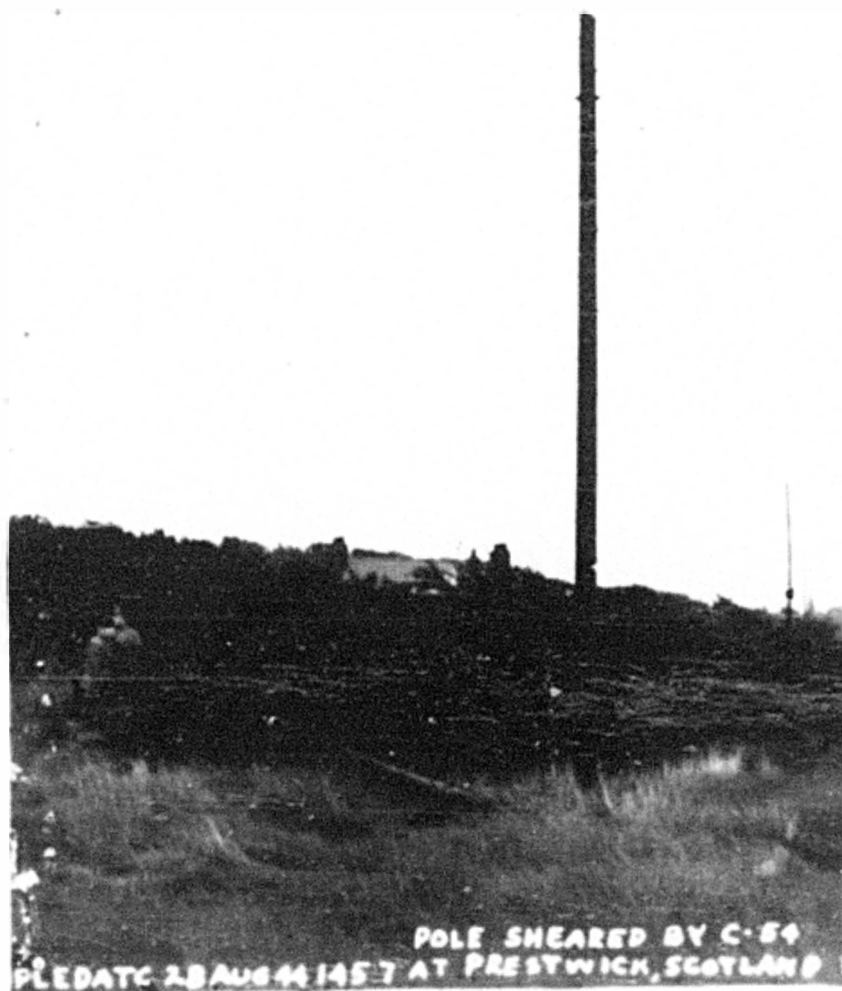
POLE SHEARED BY C-54
PLEDATC 28 AUG 44 1457 AT PRESTWICK, SCOTLAND

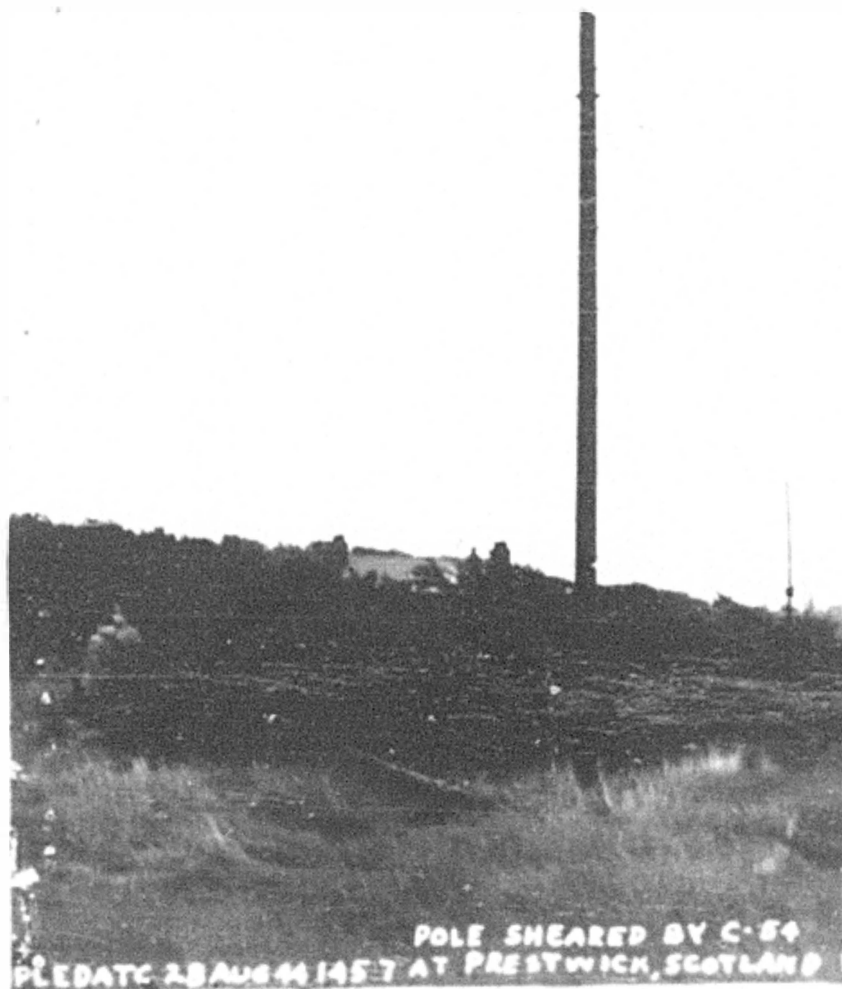
POLE SHEARED BY C-54
PLEDATE 28 AUG 44 1457 AT PRESTWICK, SCOTLAND

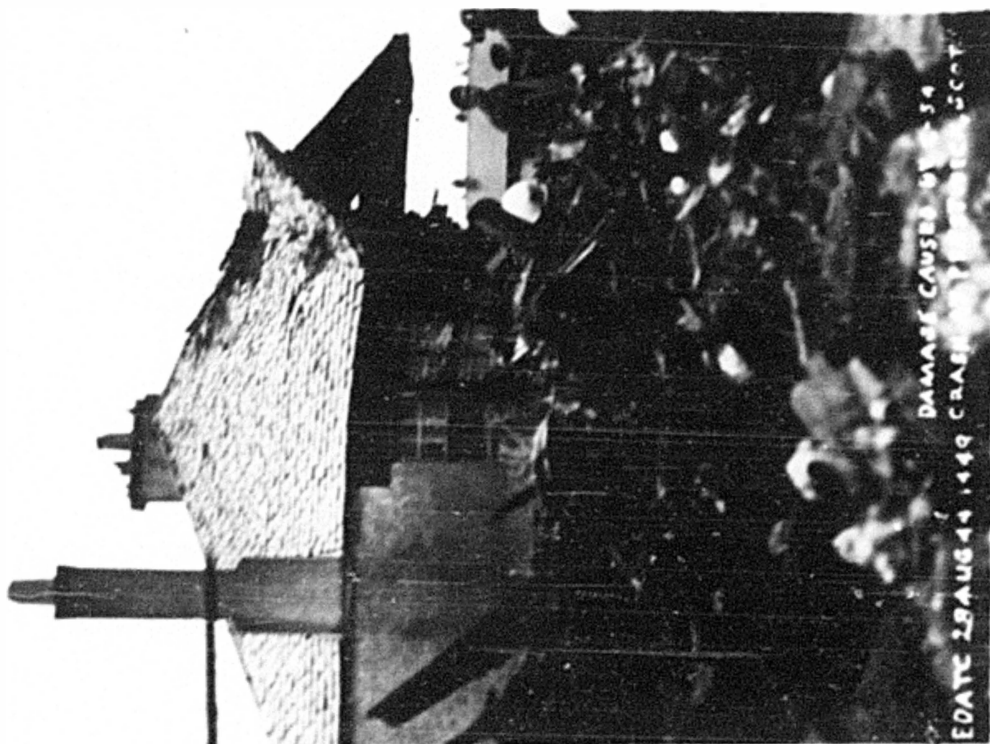
EDATE 28 AUG 44 1449 CRASHED PLANE SCOTLAND
DAMAGE CAUSED BY 34

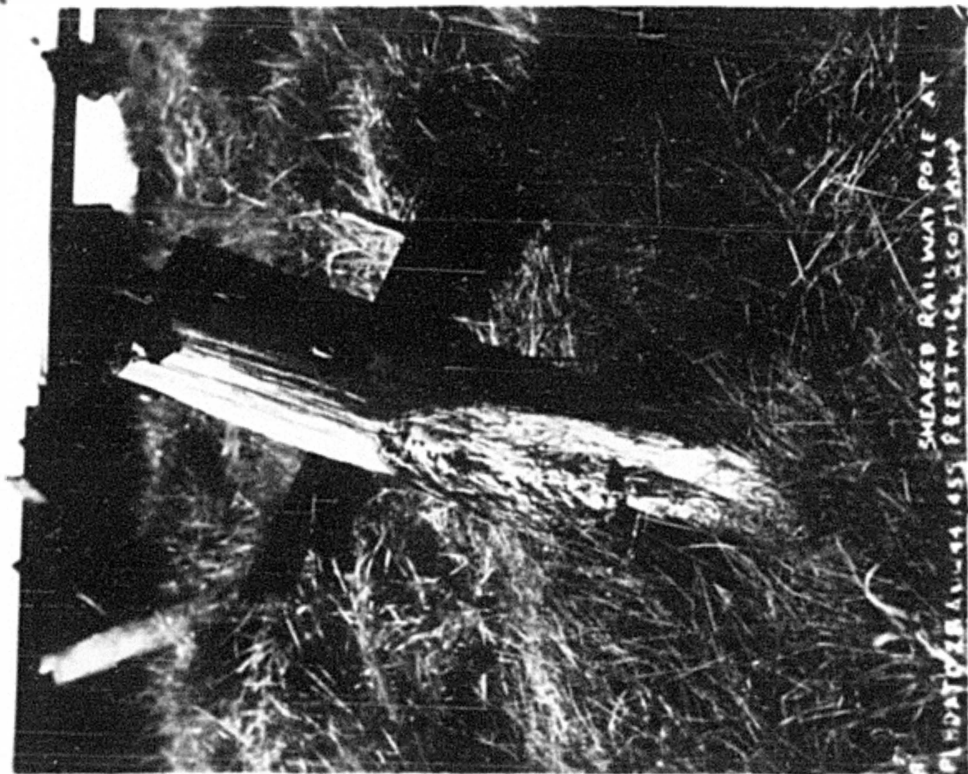
PLD DATE 28 AUG 44 1455 SHEARED RAILWAY POLE AT
PRESTWICK SCOTLAND

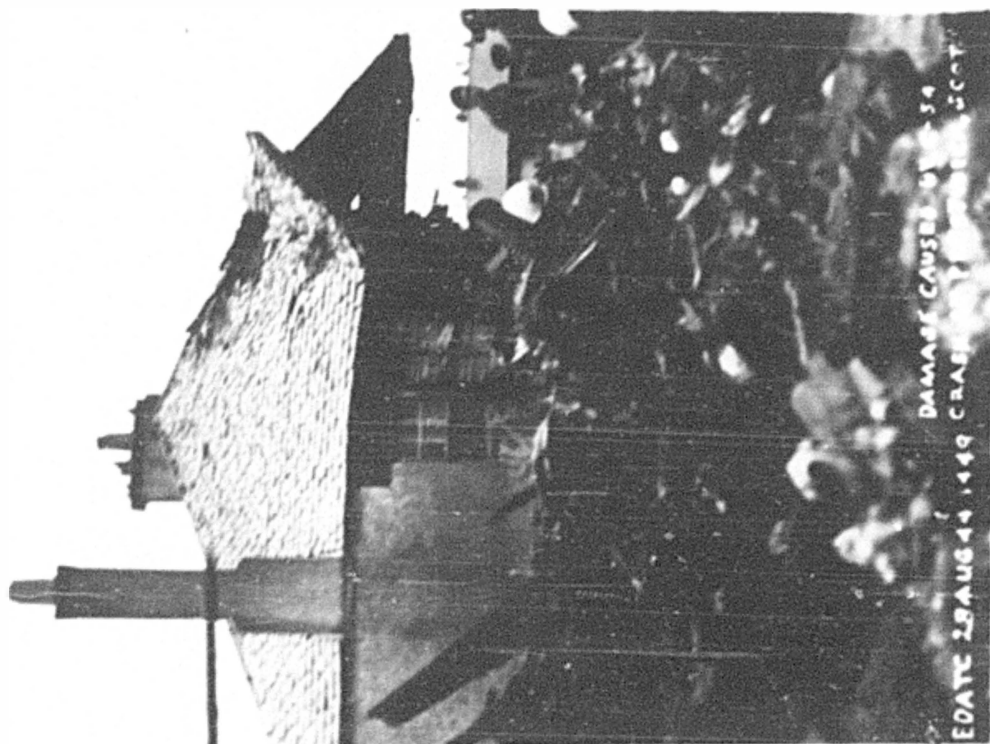
EDATE 25 AUG 44 1449 CRASHED PLANE
DAMAGE CAUSED BY 34

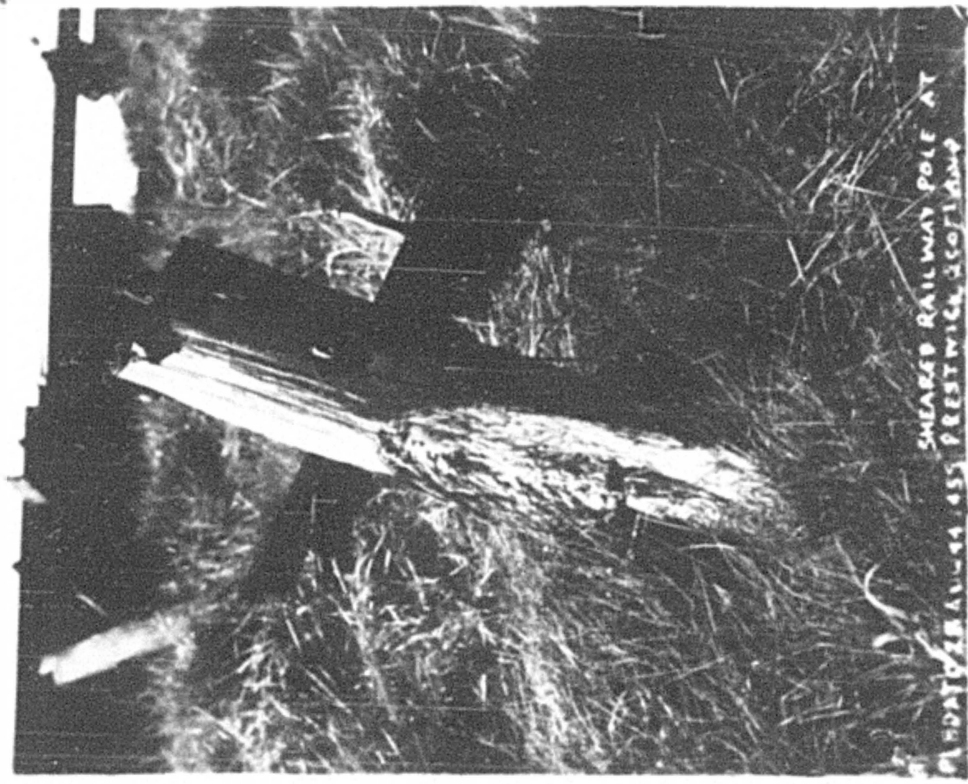
PHOTO 25 AUG 44 1455 SHEARED RAILWAY POLE AT
PRESTWICK ACOFLAMP

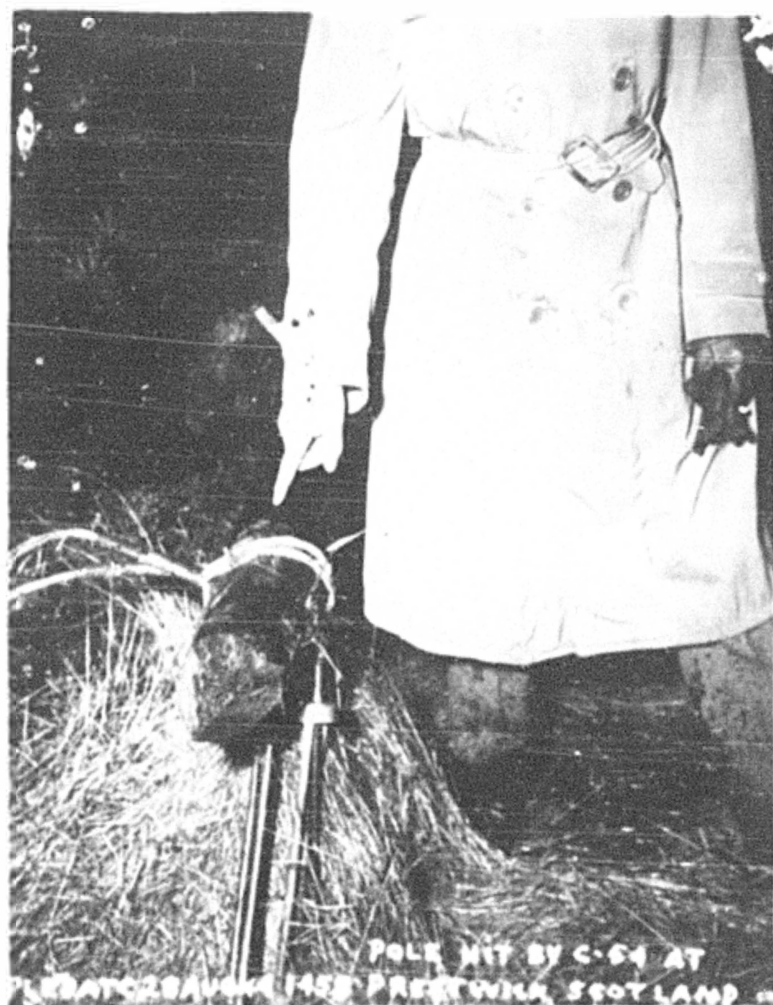
POLE HIT BY C-64 AT
LEBATOZBAUGH 1450 P.M. WILK. SCOTLAND

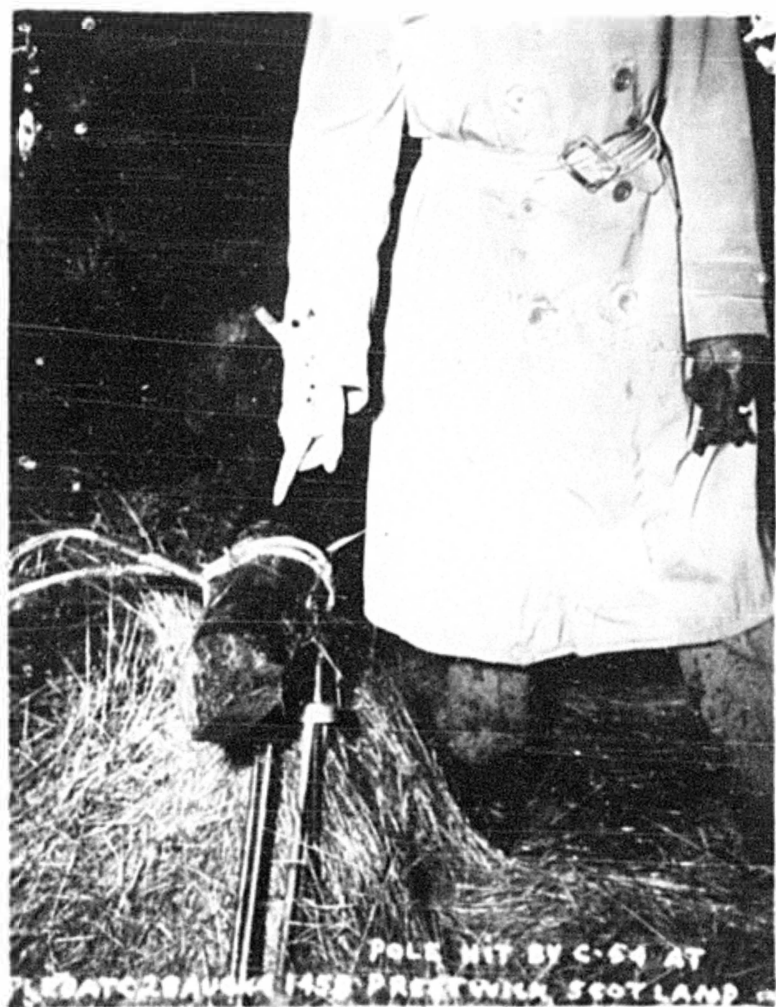
POLE HIT BY C-64 AT

LEBATO 28 AUG 1958 PRESTWICK SCOTLAND

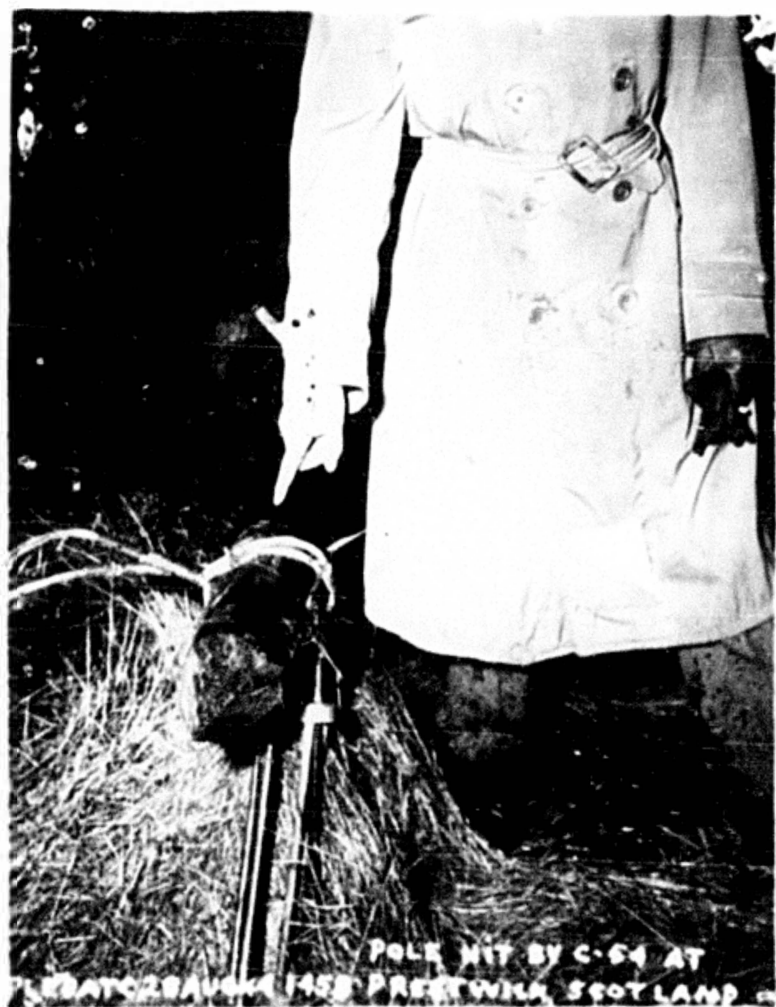
POLE HIT BY C-64 AT

LEBATCZBAUGH 1458 PREETWICK SCOTLAND

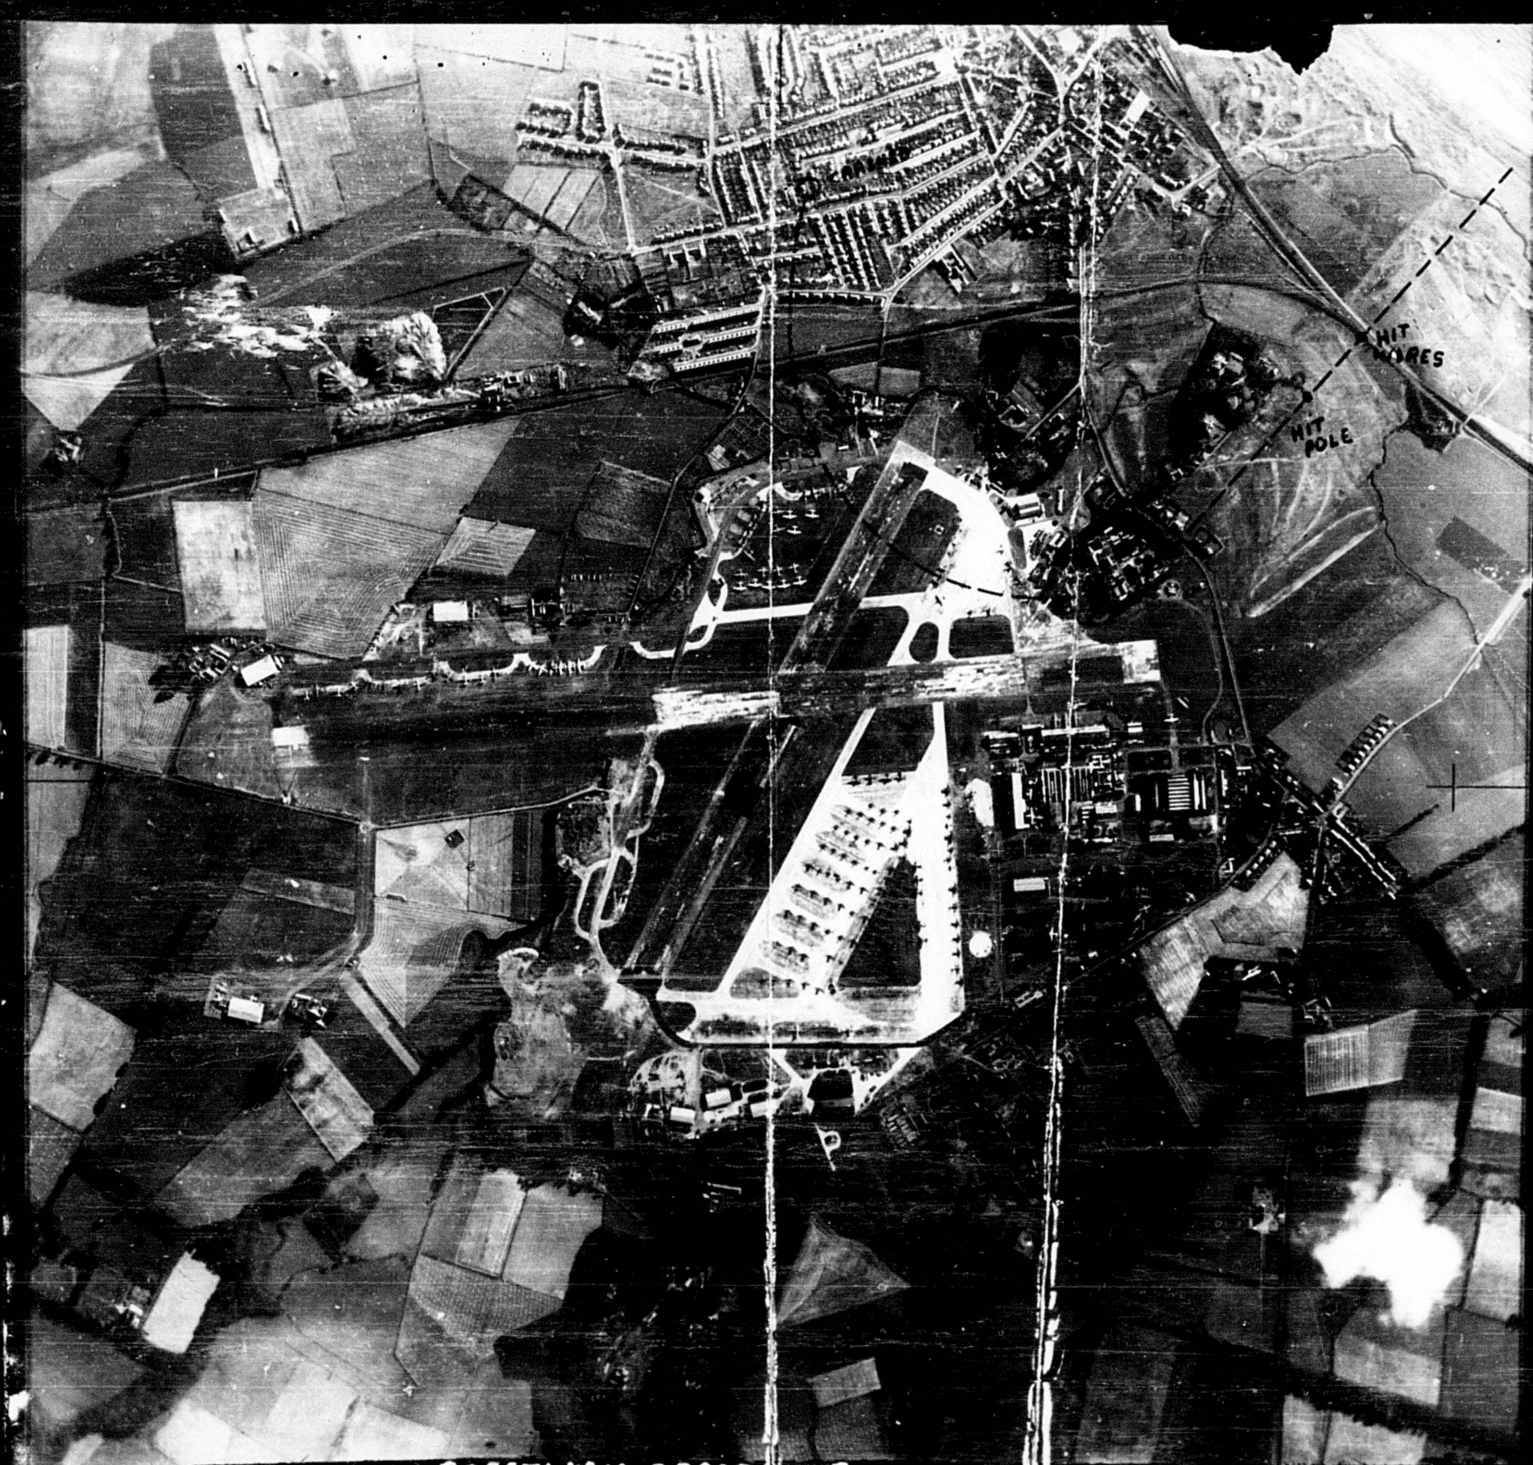
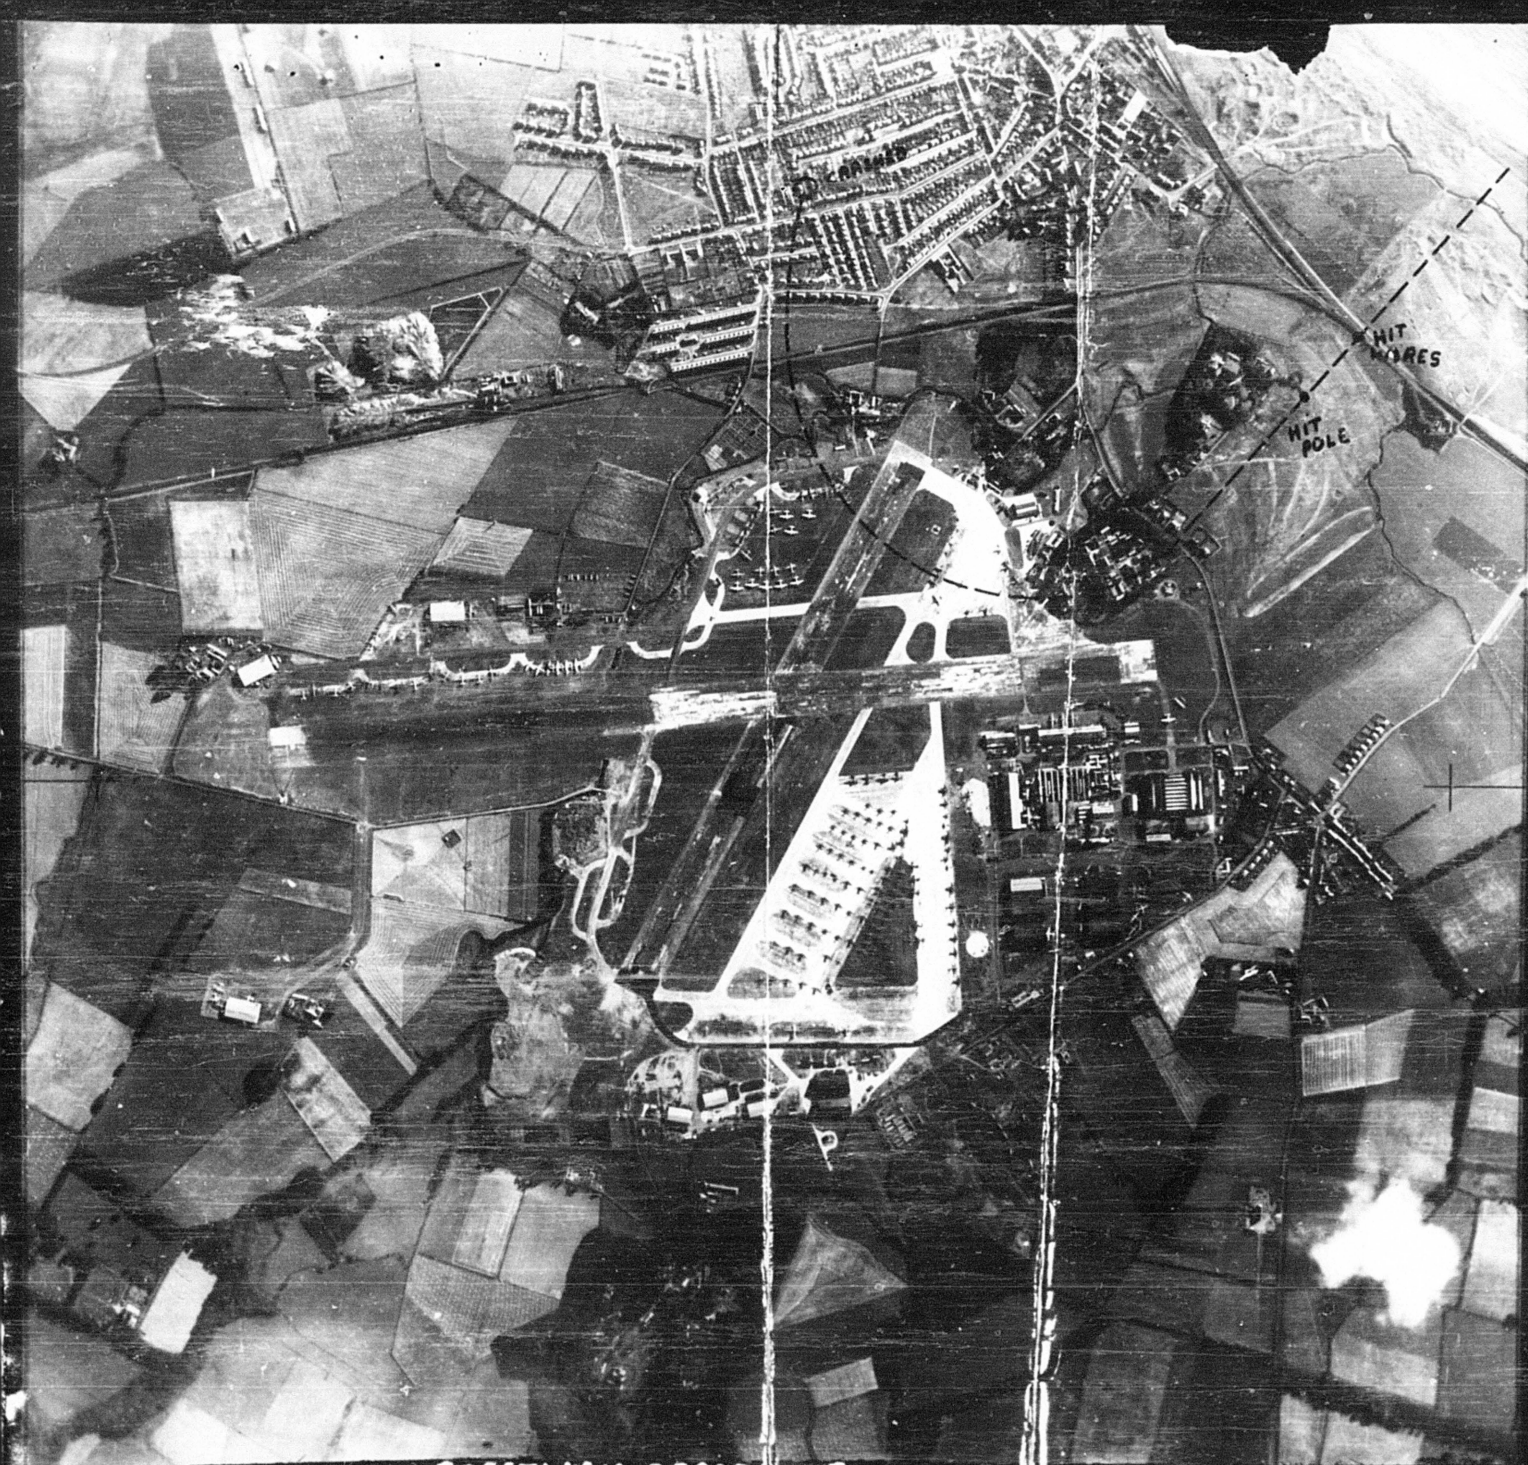
P.398. 12.AUG.44. PRESTWICK AERODROME 10000

Also attached to this report is a photograph of Prestwick Airdrome. The day following the accident telephone or telegraph wires and a pole beside the railroad track at the point marked "A" on the photograph were found broken. Near this point both pitot tubes of the aircraft were found. The altitude of this point is approximately the same as the airdrome or possibly lower. At the point marked "B" on the photograph two radio antenna poles which are 70 feet high were damaged by the aircraft. Near these poles approximately 5 feet of the right wing tip of the aircraft was found. These poles are two of several located fairly close together in a relatively small area all about the same height. There are no obstruction lights on the poles which were hit. There are obstruction lights on two nearby poles nearest the approach lane to this runway. 2nd Lt. Polito, the American Control Officer on duty, stated he was watching for the aircraft. His statement is attached. He states he saw it very low to the west of his position and so far as he could judge about over the shore, that the aircraft's navigation lights were on but not its landing lights, that he heard a snapping and crackling noise and that at this time the right inboard engine sparkled and caught fire, that the aircraft was making directly for the Control Tower, that it pulled up just in time to avoid hitting the tower and went into a right bank and turn and crashed beyond the field.
