ØBEA_Aero

Serious incident to the AIRBUS A320 registered **9H-EMU** and operated by Airhub Airlines on Monday 23 May 2022 on approach to Paris - Charles de Gaulle airport

Transmission of incorrect altimeter setting (QNH) by air traffic service, near-collision with ground during satellite approach procedure with barometric vertical guidance

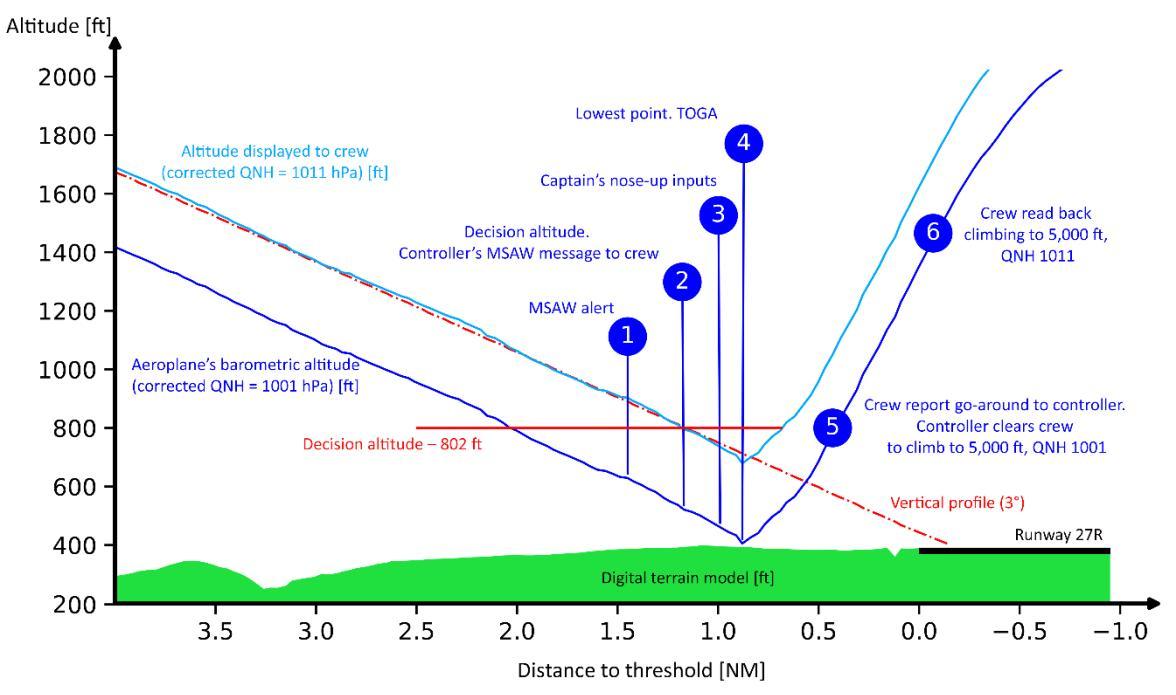
An error in the altimeter setting will mean that the aeroplane's actual altitude does not correspond to the altitude displayed. For approaches with barometric vertical guidance, the vertical profile and the associated vertical guidance are thus affected. Using a QNH value 10 hPa higher than the actual value resulted in the approach being flown on a vertical profile that was parallel to but around 280 ft (85 m) below the published vertical profile.

Figure 1: vertical profile of first approach, flight path calculated using recorded flight parameters (source: BEA)

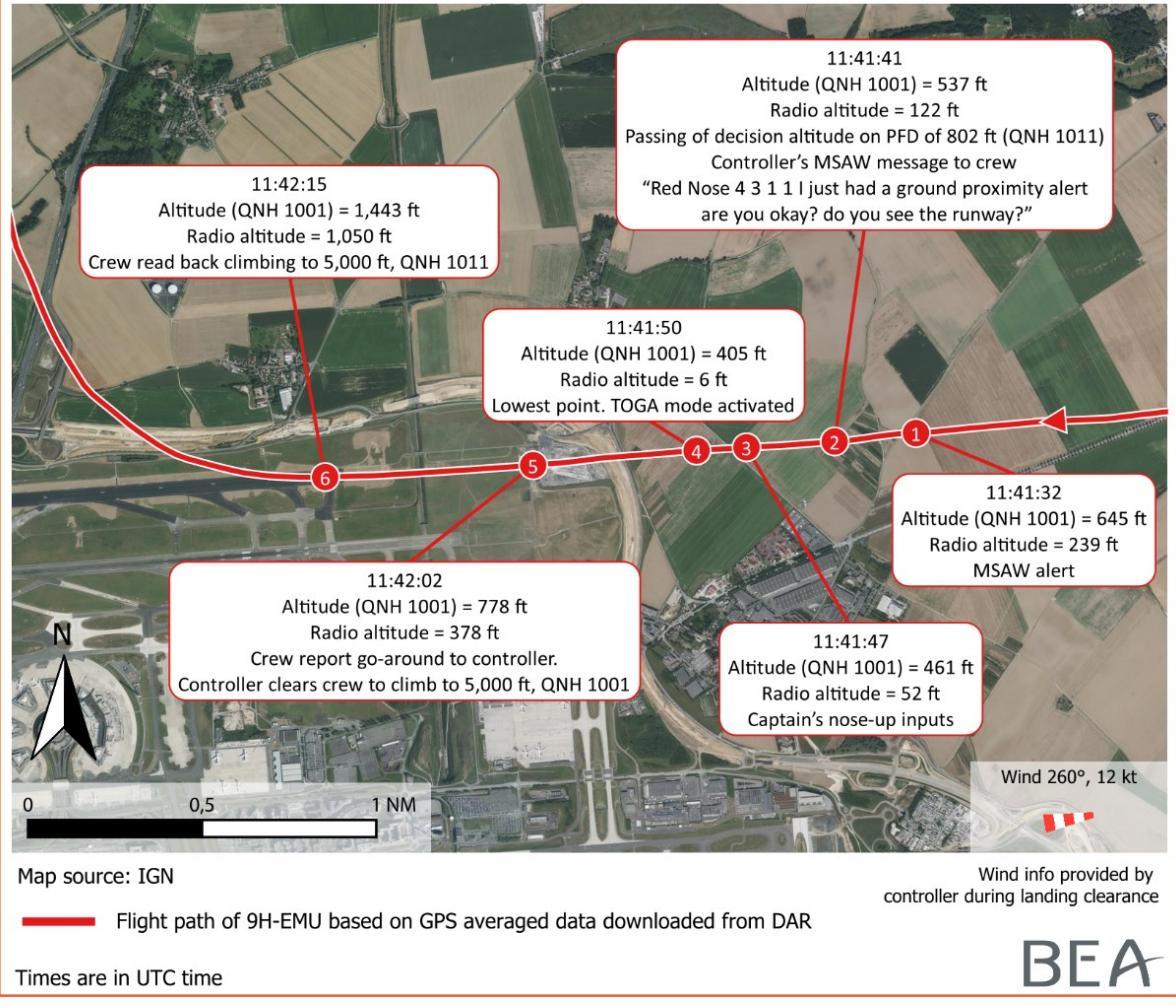
Figure 2: horizontal profile of first approach (source: BEA)

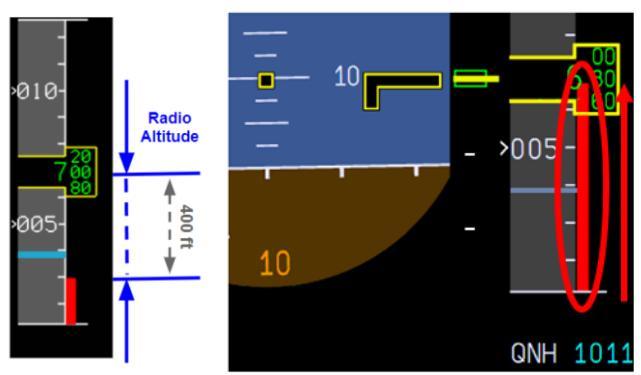
Figure 8: display of the PFD with a RA height of 400 ft (on the left), and when 9H-EMU was getting closer to the ground (on the right) with the incorrect QNH (source: Airbus)

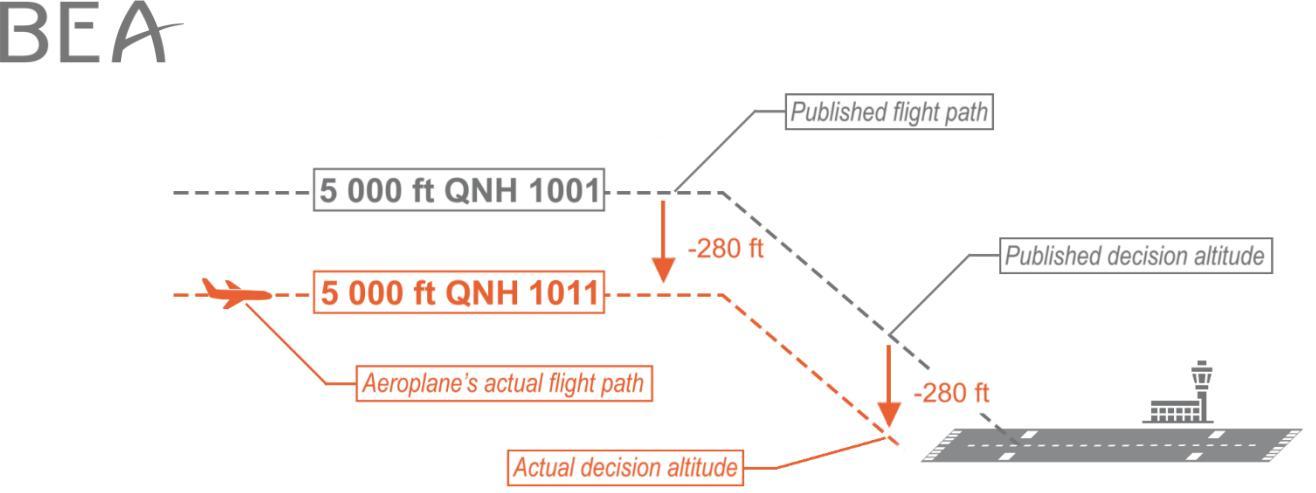
Figure 13: representation of an incorrect altimeter setting of 10 hPa (source: BEA)

The vertical guidance principle in Baro-VNAV cannot detect an incorrect altimeter setting, and the vertical deviations (V/DEV) indicator and flight director (FD) bars displayed on the PFD remain centred as long as the aeroplane is at the barometric altitude of the FMS descent profile.

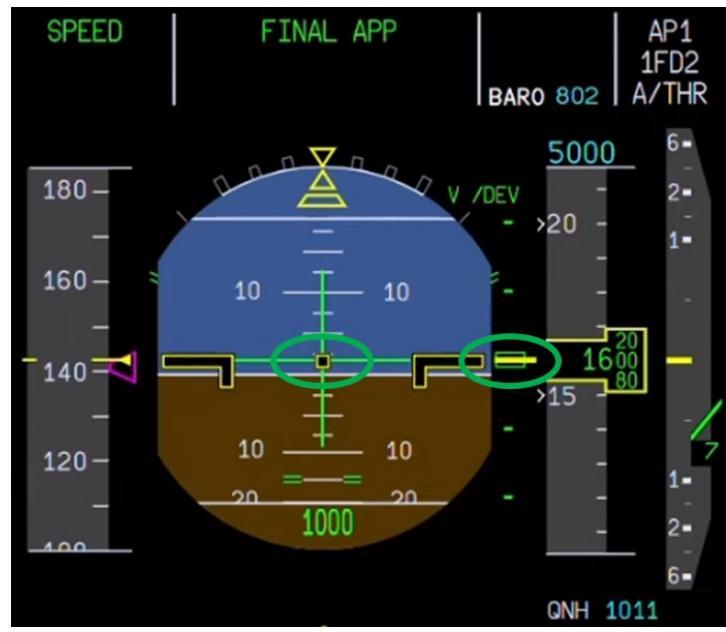
Figure 14: PFD simulation of the serious incident, with V/DEV and FD bars centred (source: Airbus)

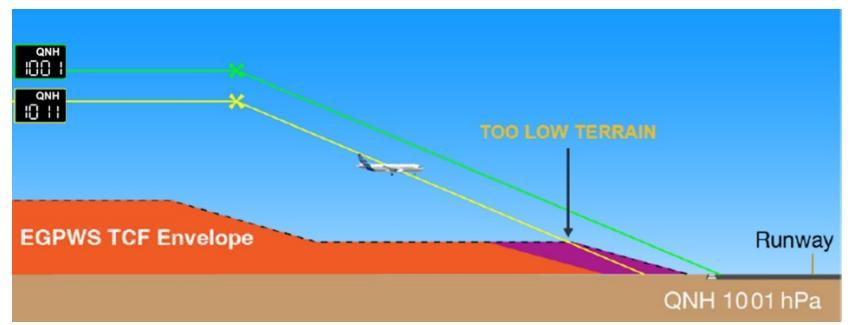
Honeywell carried out simulations to determine whether EGPWS versions subsequent to that involved in the serious incident would have triggered alerts. The TCF envelope was improved in 2003 with version -218-218 (equivalent to P/N 965-1676-002 on Airbus aeroplanes), which reduced in particular, the inhibition zone around the aerodrome. On versions -218-218 and later, using GNSS positioning, Honeywell estimated that a "TOO LOW TERRAIN" alert would have been triggered at 200 ft RA, 617 ft QNH 1001, at 11:41:35, i.e. 15 seconds before the "6 ft" callout. The alert would have been triggered 1.4 NM from the runway threshold.

Figure 17: diagram of the aeroplane's path and the more protective TCF envelope (purple area) with an EGPWS using version -218-218 or later and GNSS positioning (source: Airbus)

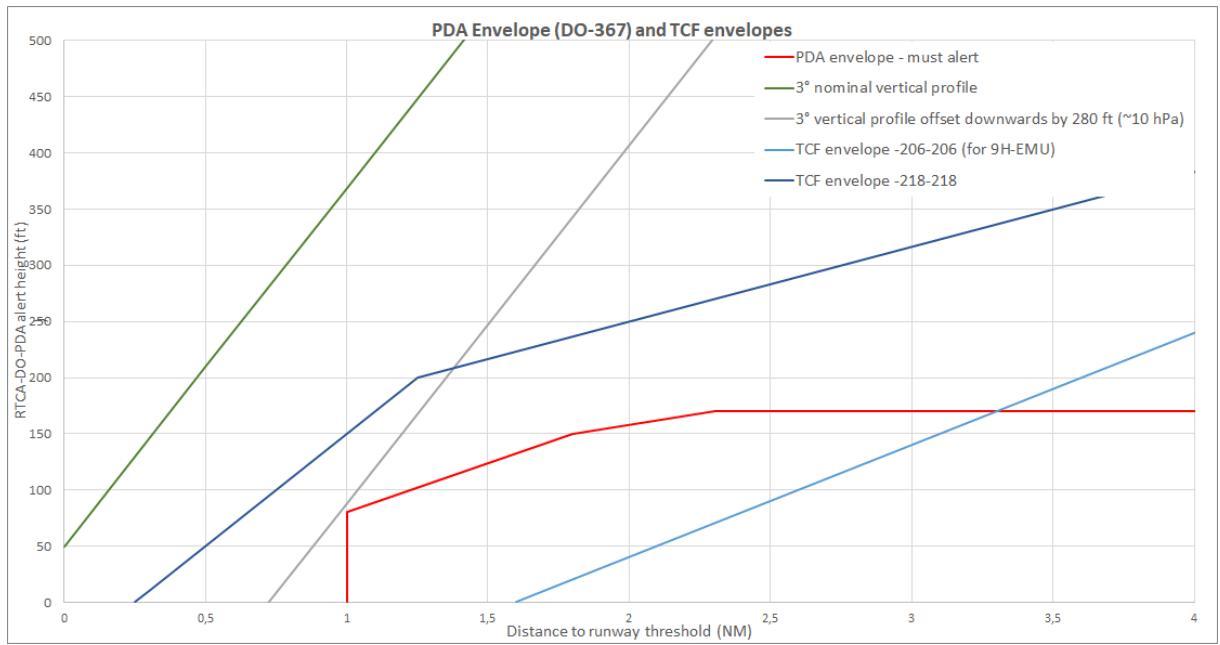
Figure 19: comparison of the PDA envelopes with a 3° approach slope approximately 280 ft below the published vertical profile (source: BEA)

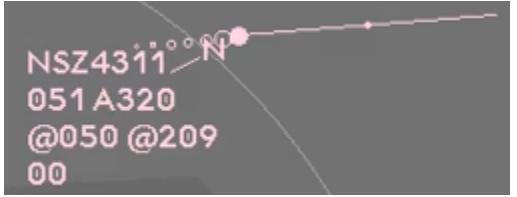
In the absence of a vertical profile display, it is difficult to detect an altitude deviation when not in level flight. During the first approach, the FAF's interception level at 5,000 ft was very short (approximately half a nautical mile), making it very difficult to detect the deviation. During the downwind leg for the second approach, the aeroplane remained in level flight for around seven minutes with a clearance at 5,000 ft. The radar label displayed a flight level altitude of "050" (or 051 depending on the precision) instead of the expected "053" (or 054) for a clearance at 5,000 ft with an altimeter setting of 1001 hPa.

Figure 31: radar label for flight NSZ4311 at 11:45:58, during the downwind leg for the second approach (source: DSNA)

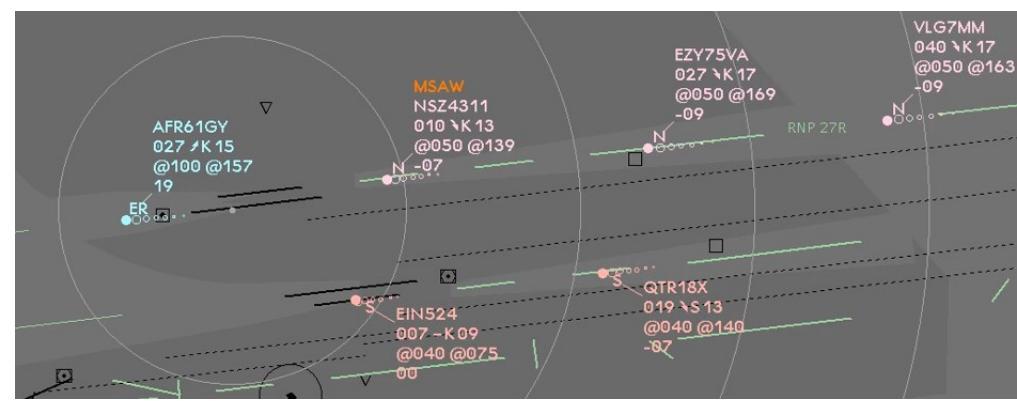
Figure 35: actual playback of the N-TWR controller's ODS radar screen when the MSAW was triggered during the first approach

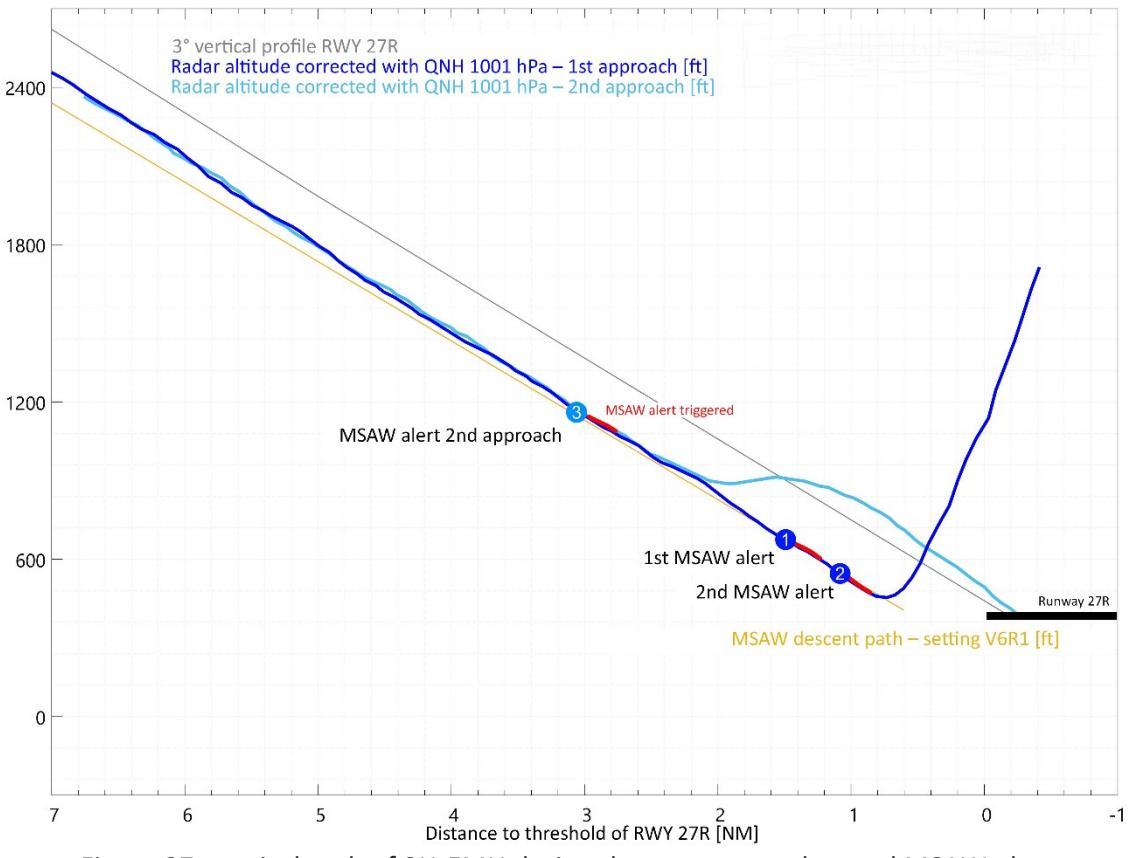
The uncertainty and inaccuracy of the aeroplane's altitude based on the radar, combined with the aeroplane's path (which was almost tangent to the MSAW descent path) and the altitude coding (within 100 ft), can explain the difference between the two approaches regarding the MSAW alerts generated.

Figure 37: vertical path of 9H-EMU during the two approaches and MSAW alerts
