WAR DEPARTMENT
U. S. ARMY AIR FORCES
REPORT OF AIRCRAFT ACCIDENT

Accident No. 4808-27.501

(1) Place Prestwick, Scotland. (2) Date 28/8/44 (3) Time 0055 GMT
AIRCRAFT: (4) Type and model C-54A (5) S. No. 92-7217 (6) Station La Guardia, New York
Organization: (7) ATC (8) Am. Airlines (9) (Squadron)

SUBJECT : Report of Crash of C-54, Number 171.

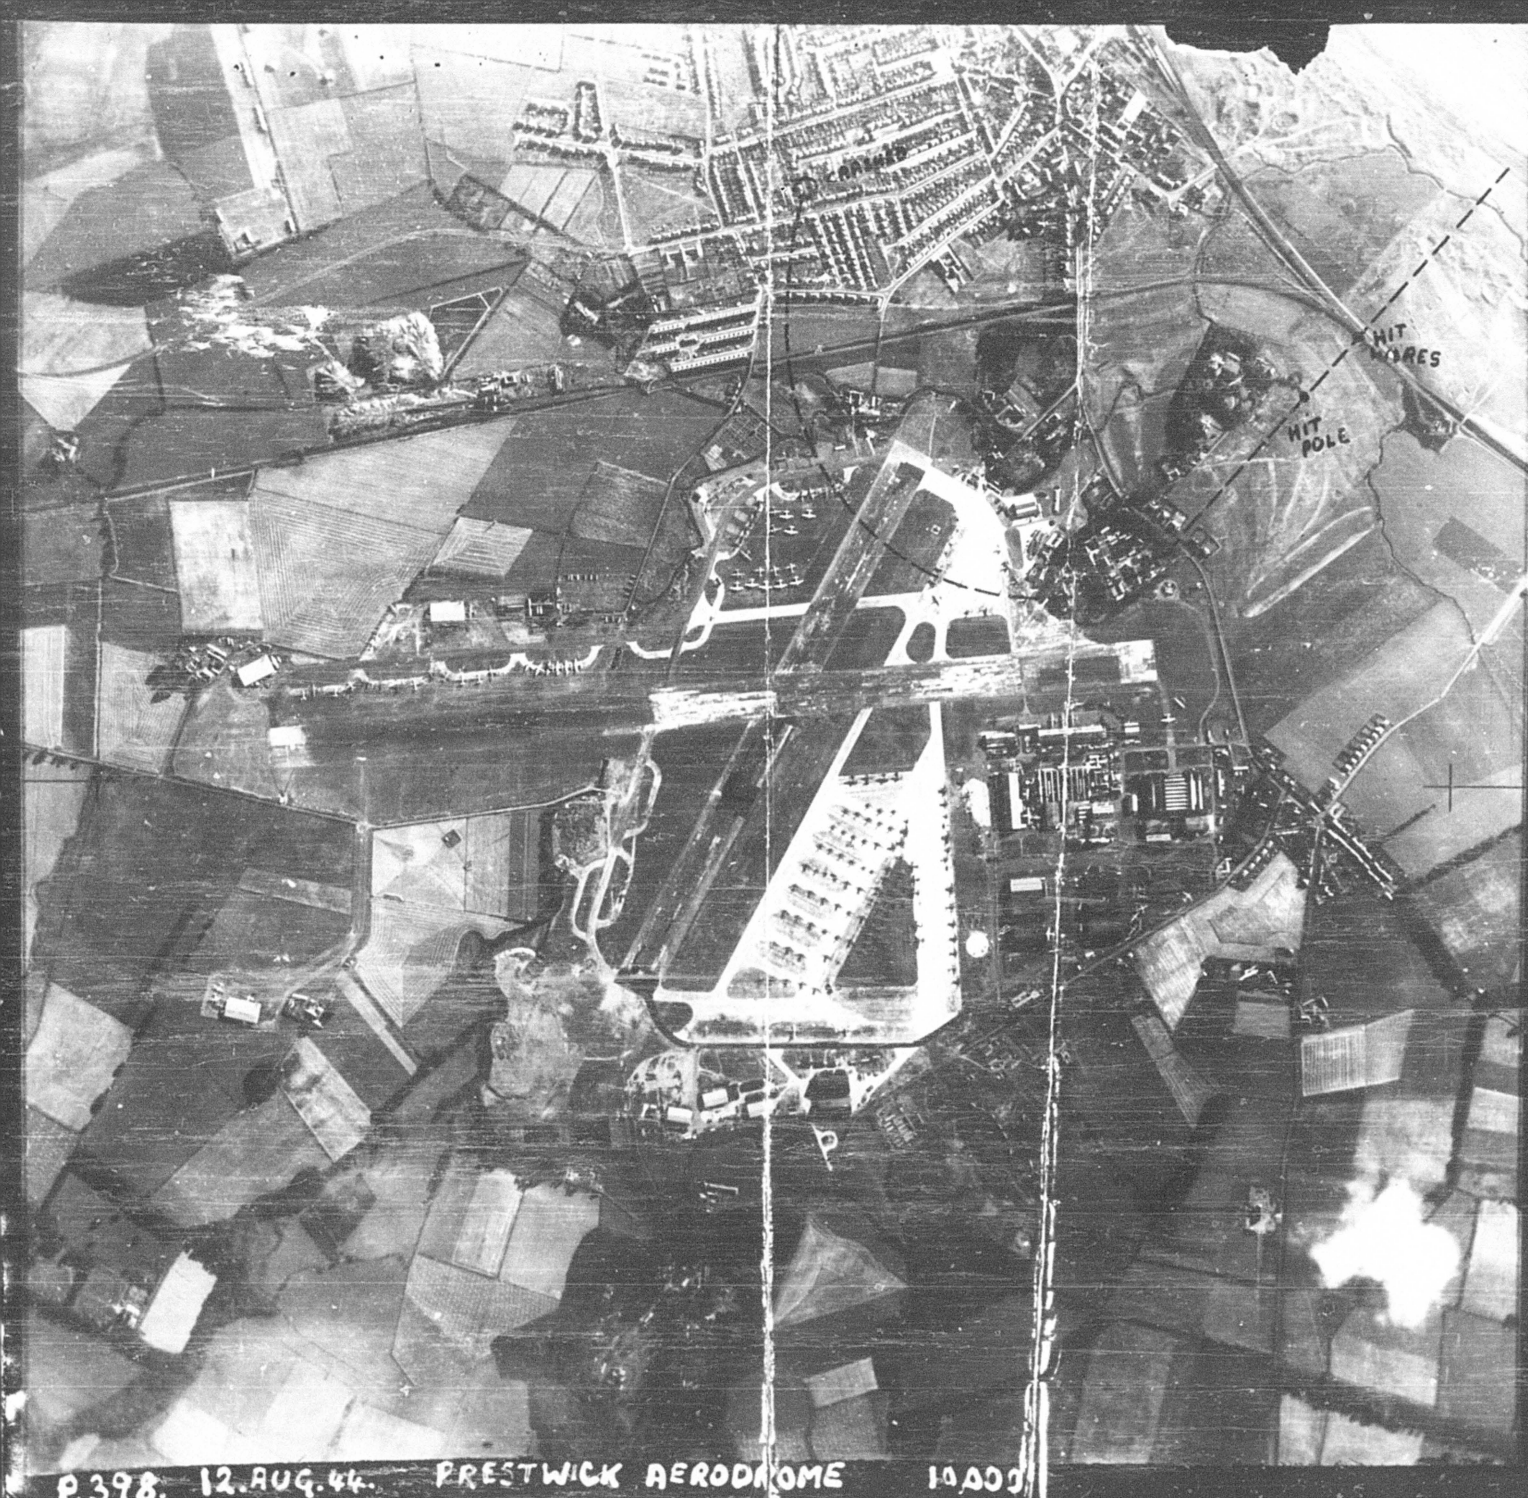
P.398. 12.AUG.44. PRESTWICK AERODROME 10000

Also attached to this report is a photograph of Prestwick Airdrome. The day following the accident telephone or telegraph wires and a pole beside the railroad track at the point marked "A" on the photograph were found broken. Near this point both pitot tubes of the aircraft were found. The altitude of this point is approximately the same as the airdrome or possibly lower. At the point marked "B" on the photograph two radio antenna poles which are 70 feet high were damaged by the aircraft. Near these poles approximately 5 feet of the right wing tip of the aircraft was found. These poles are two of several located fairly close together in a relatively small area all about the same height. There are no obstruction lights on the poles which were hit. There are obstruction lights on two nearby poles nearest the approach lane to this runway. 2nd Lt. Polito, the American Control Officer on duty, stated he was watching for the aircraft. His statement is attached. He states he saw it very low to the west of his position and so far as he could judge about over the shore, that the aircraft's navigation lights were on but not its landing lights, that he heard a snapping and crackling noise and that at this time the right inboard engine sparkled and caught fire, that the aircraft was making directly for the Control Tower, that it pulled up just in time to avoid hitting the tower and went into a right bank and turn and crashed beyond the field.
