ØBEA_Aero

Serious incident to the AIRBUS A320 registered **9H-EMU** and operated by Airhub Airlines on Monday 23 May 2022 on approach to Paris - Charles de Gaulle airport

Transmission of incorrect altimeter setting (QNH) by air traffic service, near-collision with ground during satellite approach procedure with barometric vertical guidance

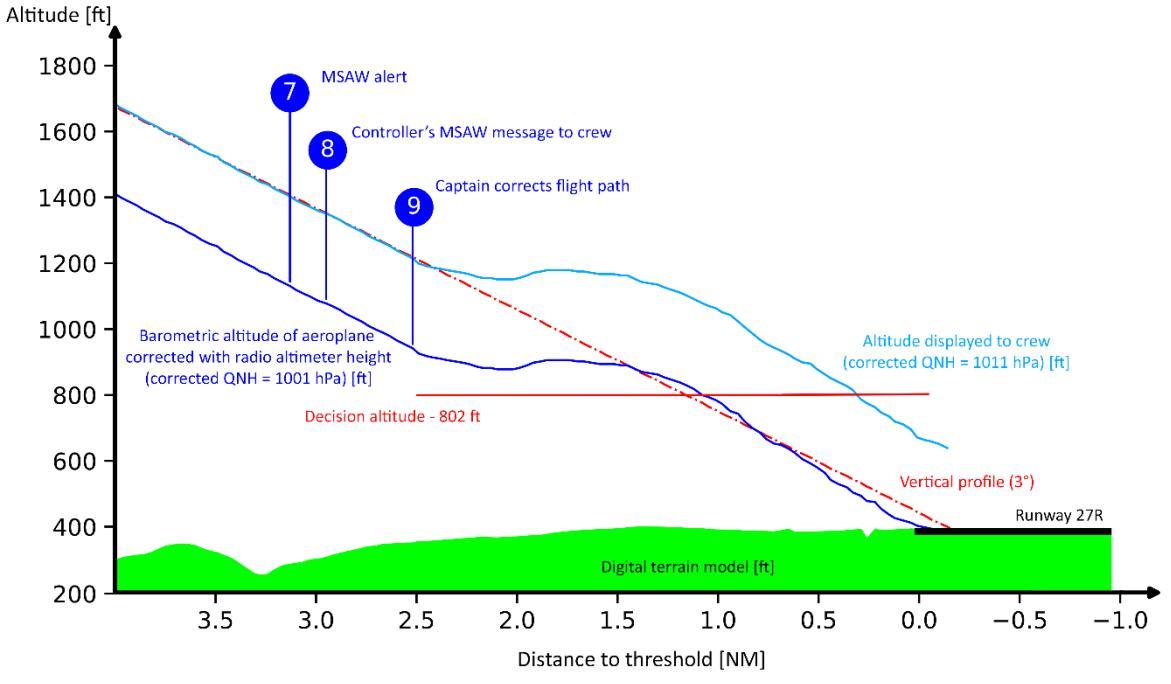
At 11:55:43, there was a new MSAW alert (see Figure 3, Point \bigcirc). The aeroplane was, this time, at an indicated altitude of 1,403 ft QNH 1011 (1,131 ft QNH 1001, 842 ft RA), at 3.1 NM from the runway threshold.

At 11:56:00, at an indicated altitude of 1,227 ft QNH 1011 (954 ft QNH 1001, 602 ft RA) and at 2.6 NM from the runway threshold, the PF made a nose-up input on his ministick (Point 9). Simultaneously, the AP disconnected. The Flight Directors (FD) were switched off eight seconds later.

Figure 3: vertical profile of second approach, flight path calculated using recorded flight parameters (source: BEA)

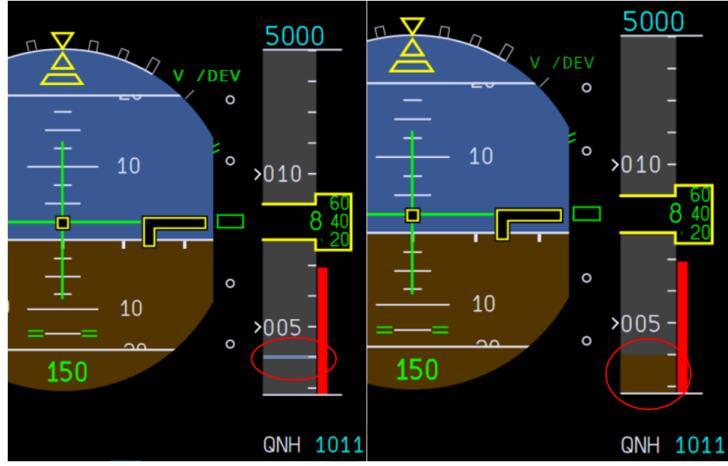
If the altimeter setting is correct and the terrain is flat before the runway threshold, the blue line (or the top of the brown strip), representing the aerodrome's altitude, should align with the top of the radio-altimeter red ribbon during the final approach. On landing, these elements are at the same level as the altitude window on the altitude scale. When the terrain is flat before the runway, an incorrect altimeter setting will result in a positional inconsistency between these two elements, as shown in the figure below.

Figure 9: representation of the aerodrome's altitude with an incorrect QNH and flat terrain before the runway, according to the two Airbus EIS models (left: EIS1, as used on 9H-EMU; right: EIS2) (source: Airbus)

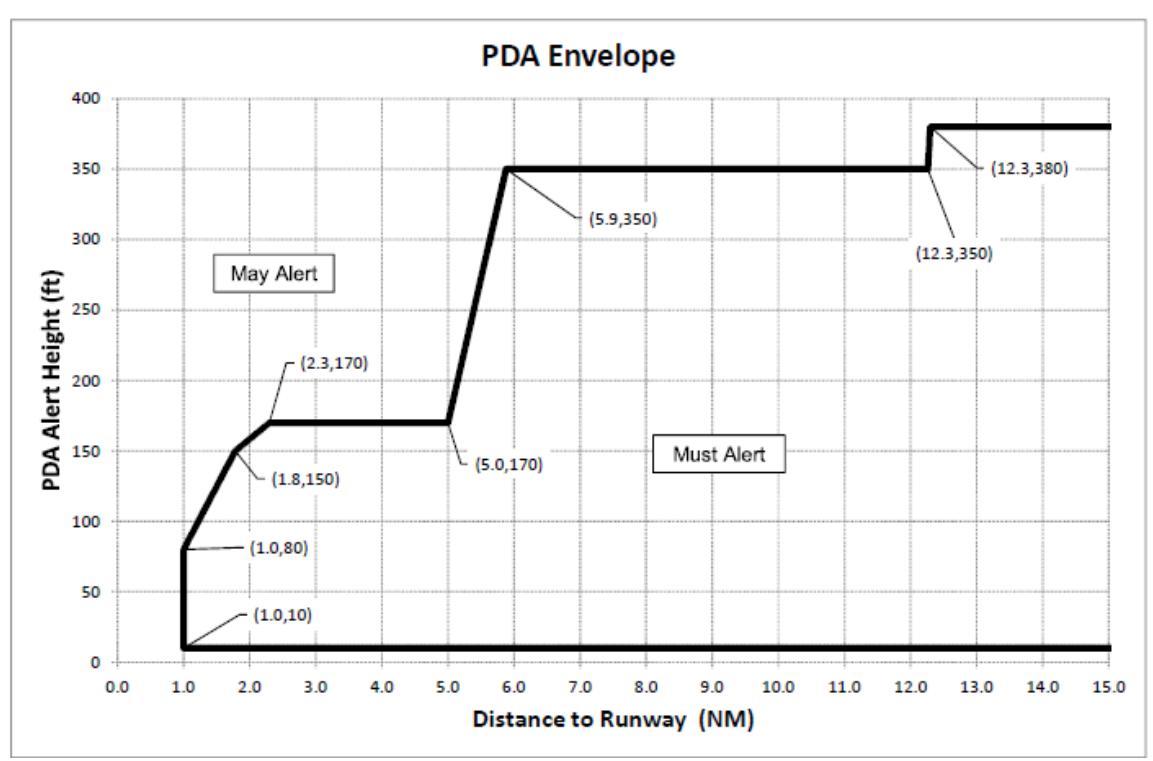
Figure 18: PDA envelope (source: RTCA DO-367)

It can also be seen that the 3° slope, approximately 280 ft below the published vertical profile and associated with an incorrect altimeter setting of 10 hPa, does not fall into the "*must alert*" PDA envelope of the current standard RTCA DO-367. Therefore, for all TAWS of aeroplanes designed and produced today, there is no requirement for a PDA alert to be triggered in conditions similar to those of the serious incident involving 9H-EMU.

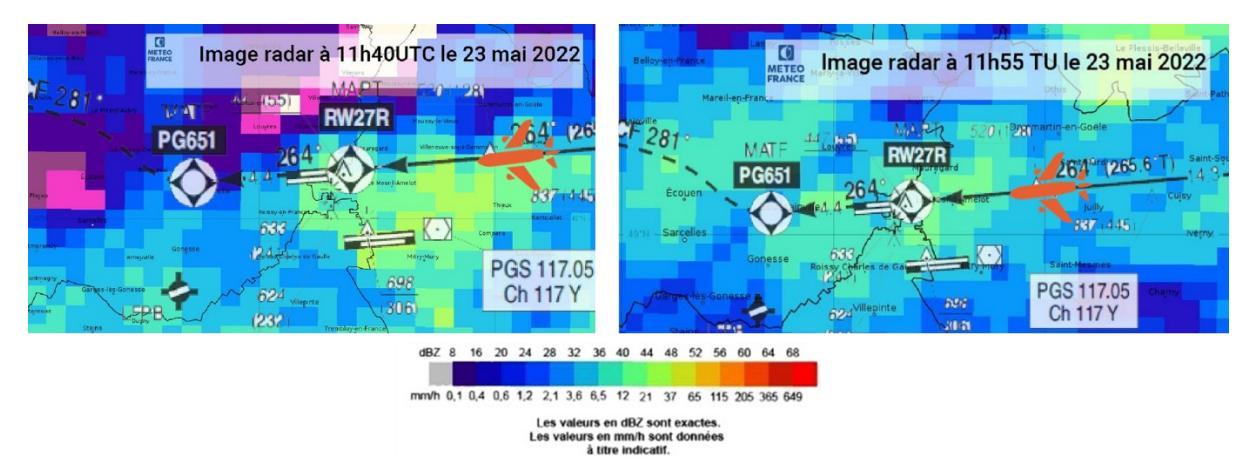
The radar images centred on CDG at 11:40 and 11:55, corresponding approximately to when the MSAW alerts were triggered during the two approaches made by 9H-EMU, show rain showers in the vicinity of CDG, with greater intensity during the first approach:

Figure 20: precipitation radar images at 11:40 and 11:55 (source: Météo-France)

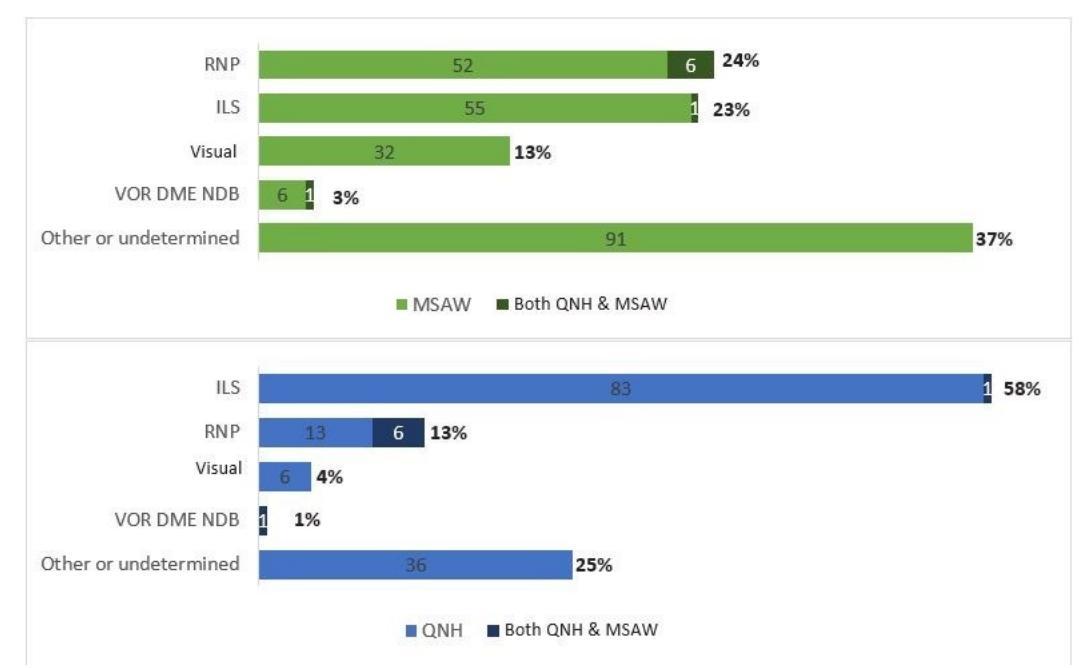
Figure 41: breakdown of occurrences, MSAW in green and QNH in blue by types of approach

Reports relating to MSAW are mainly associated with RNP (24%) and ILS (23%) approaches. The QNH errors notified are mainly associated with ILS approaches (58%); RNP approaches concern 13% of these reports relating to an incorrect altimeter setting. In both cases, the data available does not identify the type of RNP approach.

It should also be noted that RNP approaches account for 13% of the reports and six of the eight occurrences corresponding to the "QNH" and "MSAW" analyses. Conversely, the ILS approaches account for 58% of the reports but only one of the eight occurrences corresponding to the "QNH" and "MSAW" analyses.

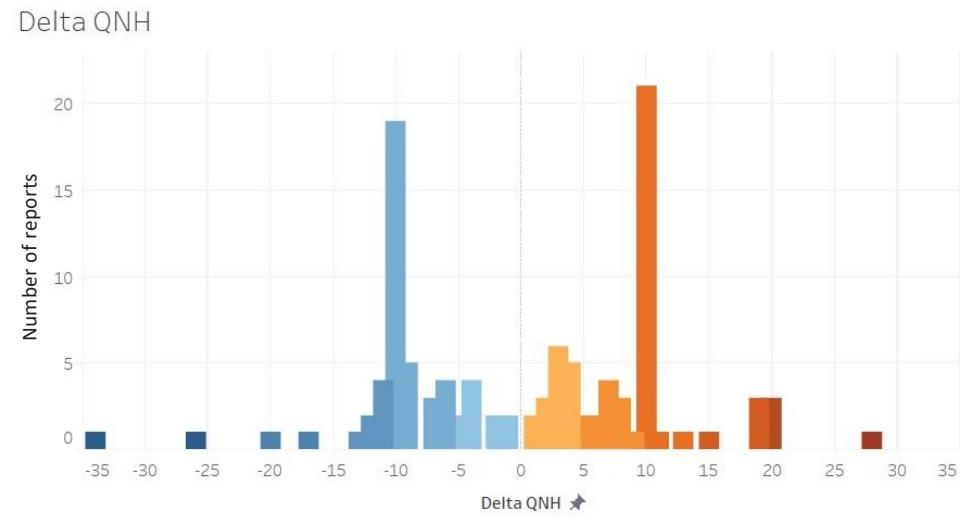
Figure 43: number of occurrence reports as a function of the value of the deviation from the actual QNH (source: DSAC)

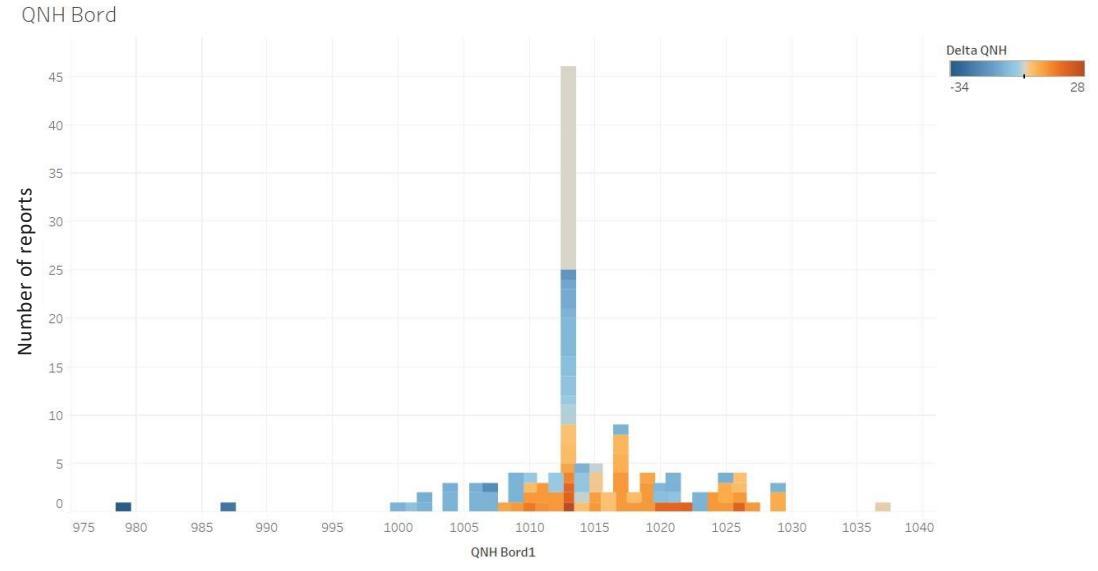
Figure 44: number of occurrence reports as a function of the value of the QNH entered (source: DSAC)

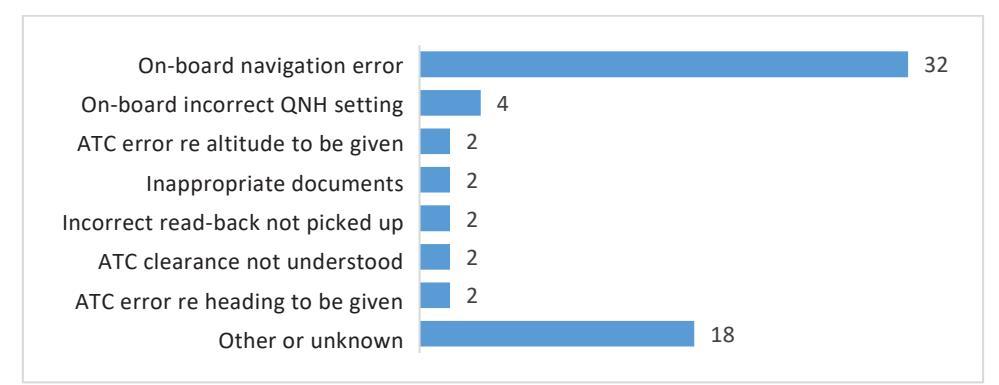
Figure 45: cause of "near-CFIT" occurrences on approach according to the DSNA ad hoc typology

At least half of these occurrences are the result of an on-board navigation error, i.e. following a different horizontal and/or vertical profile to that published and/or instructed by the controller. Four occurrences were identified as being the result of an incorrect altimeter setting, whatever its cause⁶⁹.

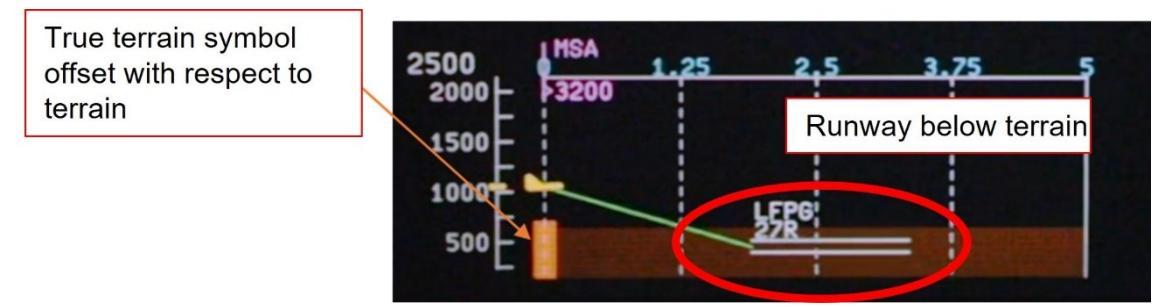
The crew can detect an inconsistency in the representation by carefully comparing the "True terrain symbol", the modelled terrain ahead of the aeroplane and the runway. In particular, in the case of an incorrect and overestimated QNH, the runway will be represented below ground level, and the "True terrain symbol" will be offset with respect to the modelled terrain. Depending on the scale used for the VD, this offset may not be easily identifiable by the crew.

Figure 48: A350 Vertical Display in the case of an incorrect QNH (1011 hPa instead of 1001 hPa) (source: Airbus)

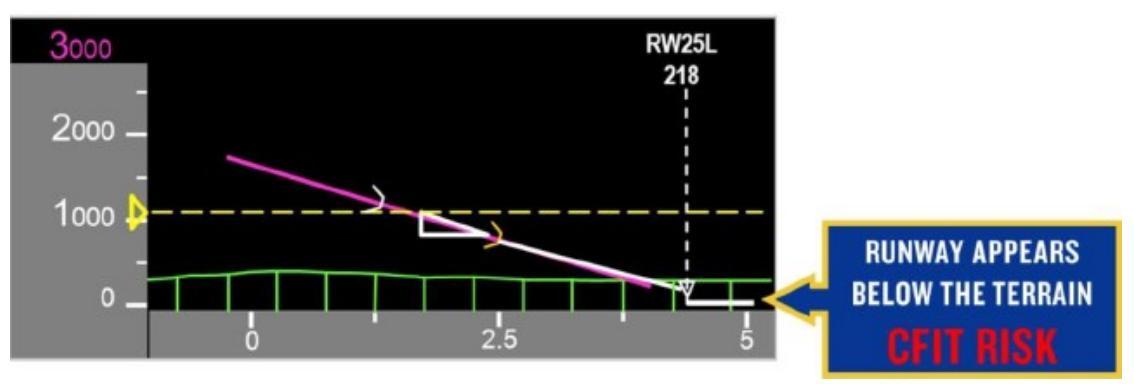
Figure 49: Boeing 737 VSD with QNH > actual QNH (source: Ryanair flight safety bulletin)

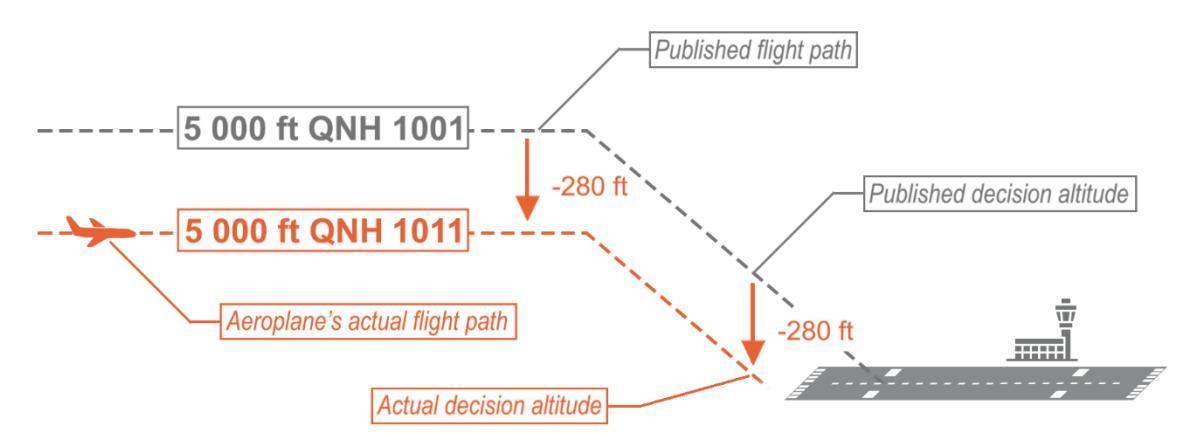
On the intermediate approach, the crew were twice given a QNH value with an error of 10 hPa by the approach air traffic controller (1011 hPa instead of 1001) which they used to set the aeroplane's altimetric systems. Now an error in the altimeter setting results in a difference between the aeroplane's actual altitude and the altitude displayed. For approaches with barometric vertical guidance, the vertical profile and the vertical guidance are affected. This meant that on using a QNH value 10 hPa higher than the actual value, the approach was carried out on a vertical profile around 280 ft below the published vertical profile without the crew being aware of this and without any external visual references.

Figure 51: impact of incorrect QNH on vertical profile (source: BEA)
